The Henry L. Russell House
West Grove Township
Davis County *Bloomfield vicinity*
Iowa

HABS No. IA-137

HISTORIC AMERICAN BUILDINGS SURVEY

Henry L. Russell House

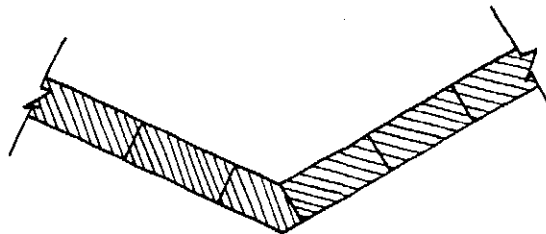
Fig. 1.

1. Dimensions: 13'2" average from corners, but inexact. For example, the southwest wall is 12'8".
2. Foundations: Full basement with brick walls and dirt floor. Inaccessible.
3. Walls: Soft brick laid up in a rather random 6-8 course common bond with flush joints, two bricks (approximately 9") thick, with corner pilasters. The bricks are of irregular size and coloring, the latter ranging from a cream or buff to orange-red and gray-brown. A few are partially glazed. The outer bricks are a fairly uniform orange-red. Bricks used at corners are shaped to triangular points at one end (Fig. 1). A date stone was inserted in the east wall, in the spandrel between the windows, that read "H.L. Russell A D 1859".

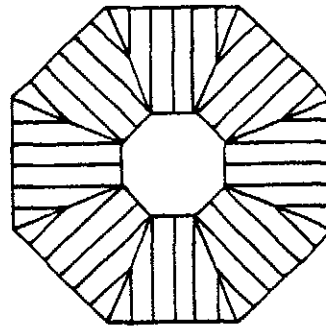
Fig. 2.

the second floor ceiling) consists of sawed rafters radiating from an octagonal "compression ring" around the central chimney. They are parallel to one another on each side, this achieved by a three-"pronged" rafter at each corner (Fig. 2). Machine cut square nails are used throughout the house; modern work uses round wire nails. There is no evidence of mortise-and-tenon construction.

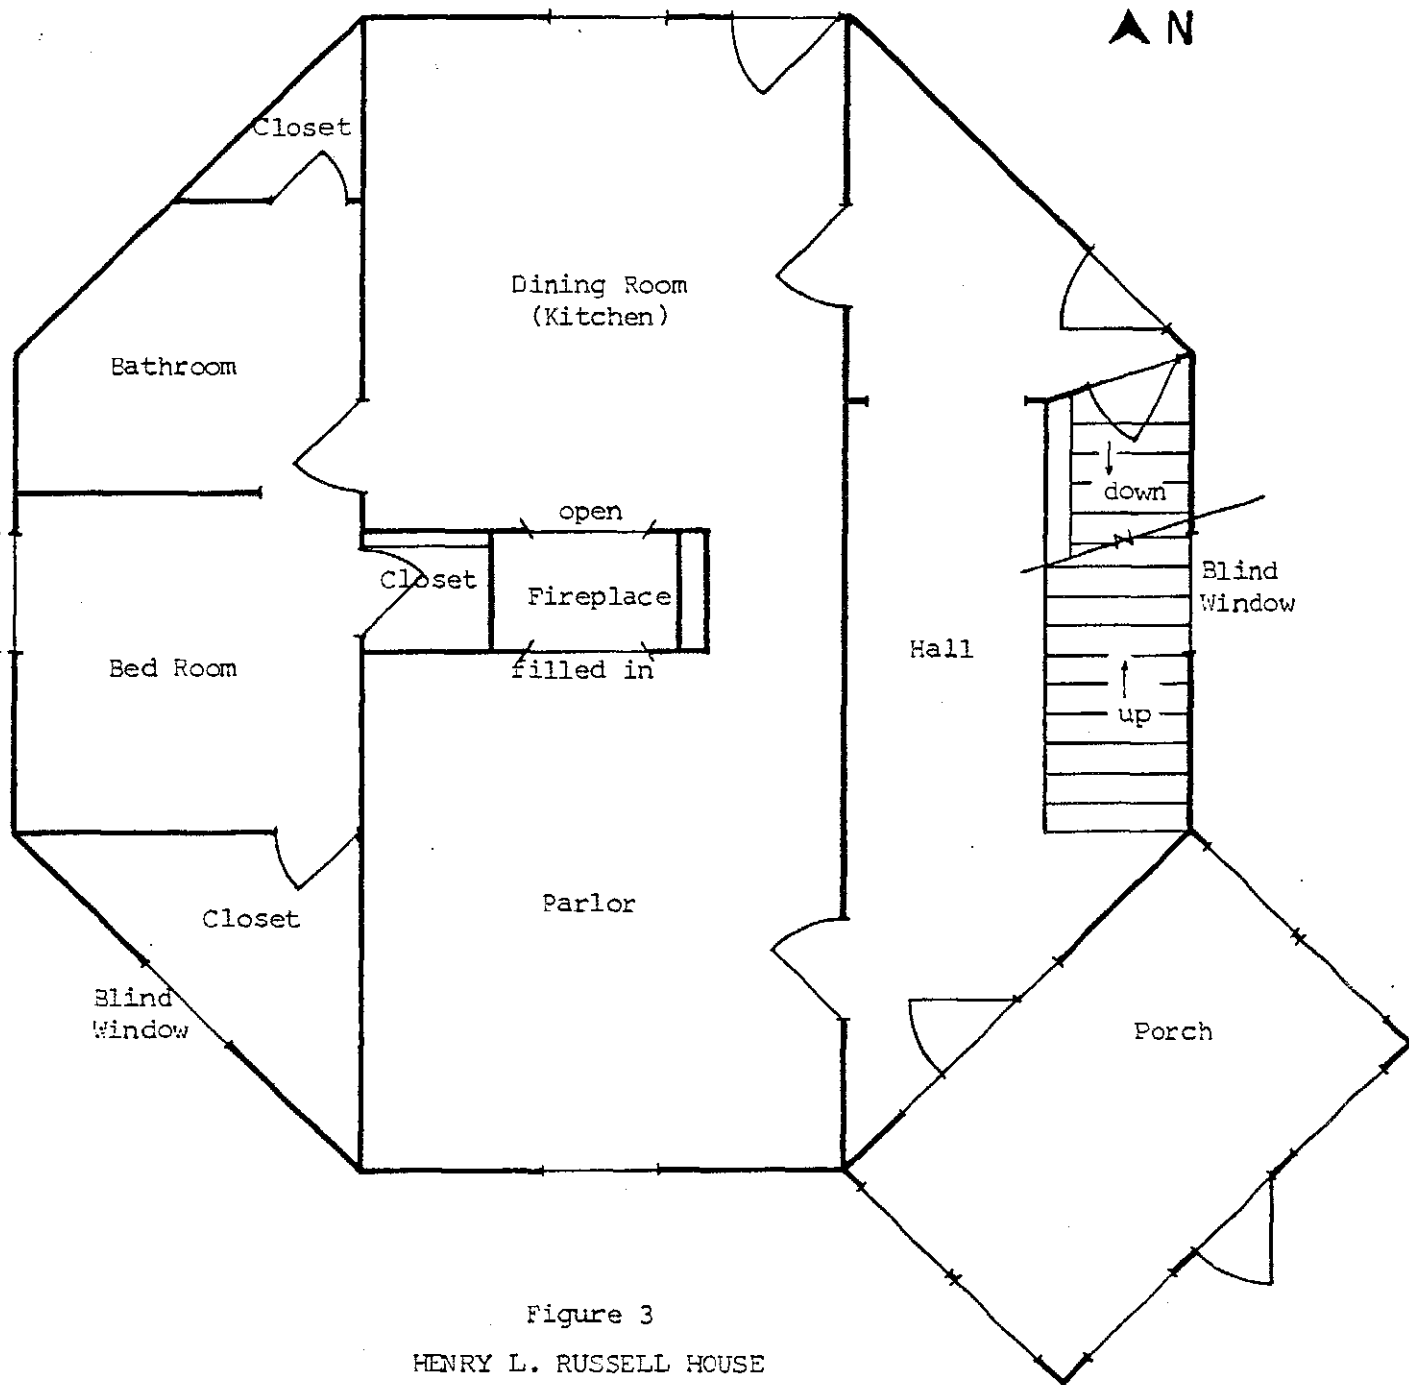
Figure 3
HENRY L. RUSSELL HOUSE
First Floor Plan
Approx. 3/16 scale

- a. First Floor. As noted previously (B.4), two brick bearing walls run north-south through the house, dividing the interior into three major parts, the outer two of equal width but narrower than the center section. The main entrance opens directly into a hall, with staircase along the east wall. Toward the north end of this hall is a doorway leading to a small, triangular vestibule. The center section of the house features a nearly square parlor at the south end. On its north wall is a fireplace. A short passage on the east side

of the fireplace (as long as the fireplace stack is deep) leads to what is now the kitchen (originally the dining room). Here, there is a fireplace centered in the south wall, and beside it a built-in cupboard with drawers below, part of which may be original. On the west wall there was a built-in desk and cupboard which has been removed, leaving a hole about 4' wide and 6' high in the brick bearing wall.

The west side of the house has a triangular closet at the south end, a small bedroom off which is a very small rectangular closet set beside the fireplace chimney, and a polygonal bathroom and triangular cupboard in the north end.

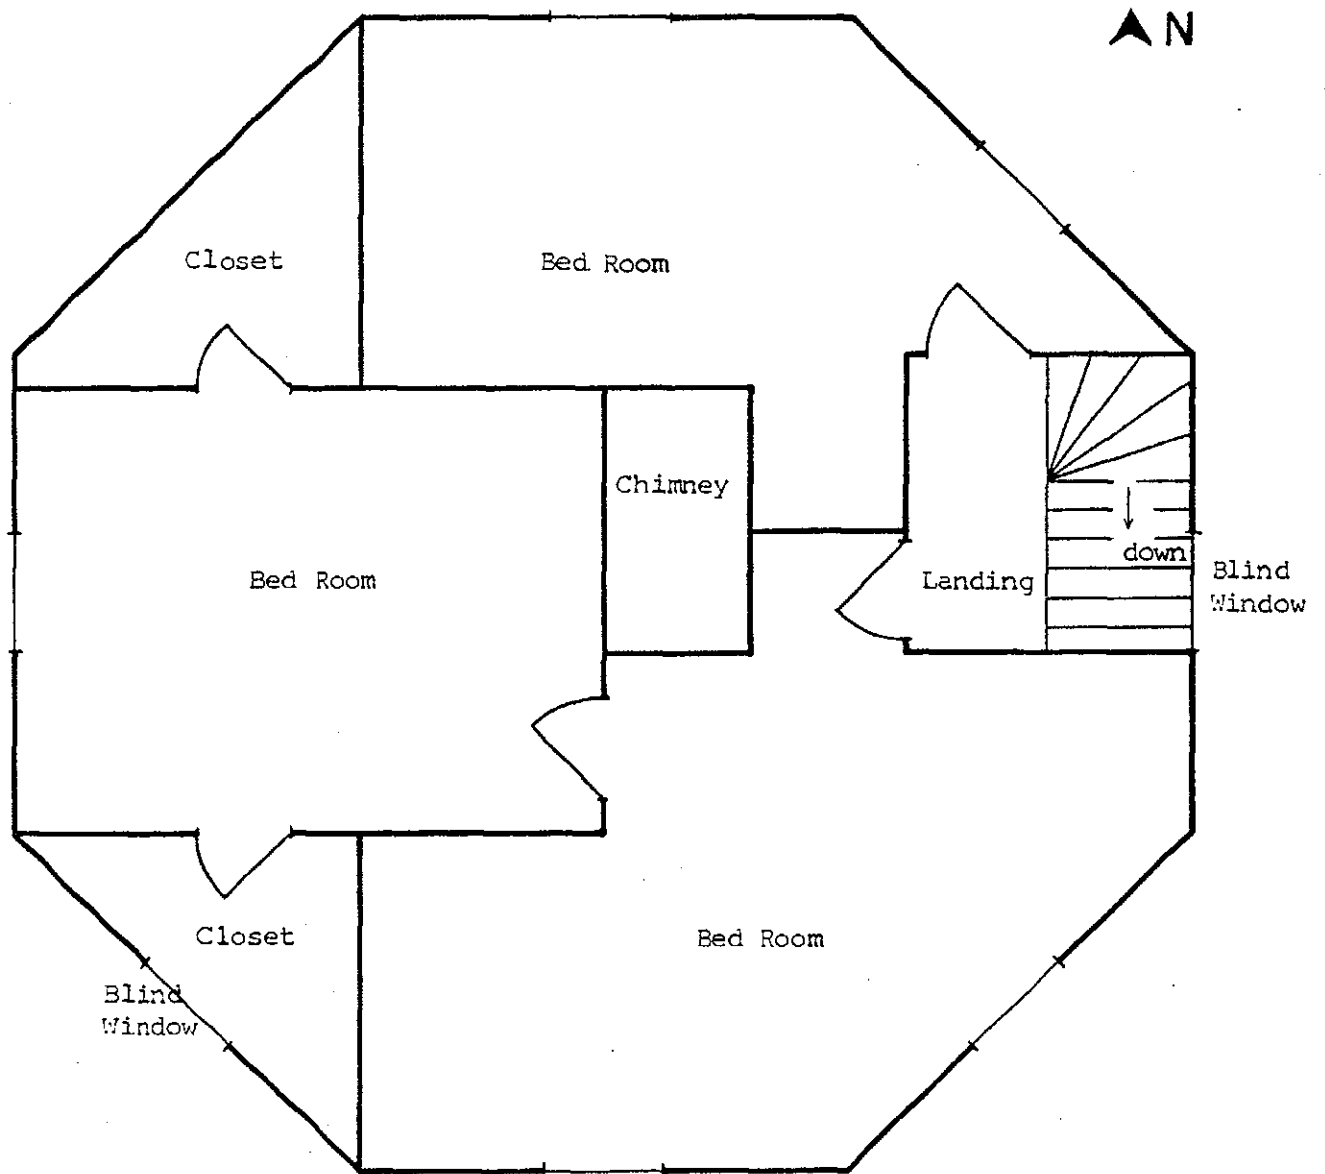
Figure 4
HENRY L. RUSSELL HOUSE
Second Floor Plan
Approx. 3/16 scale

- b. Second Floor. While the main rooms on the first floor are all rectangular, this is not the case on the second floor. A short landing-hall leads to irregularly shaped rooms on north and south. Only the room on the west is rectangular. Triangular closets are located on either side of this room, along the southwest and northwest walls.
